TEST REPORT

Report No. : HL70049/2008

Product Description: LCD Monitor Arm
Style/Item No.: EGL-200
Manufacturer/Vendor: Eastern Global Corporation
Country of Origin: Taiwan

Compression Strength Test

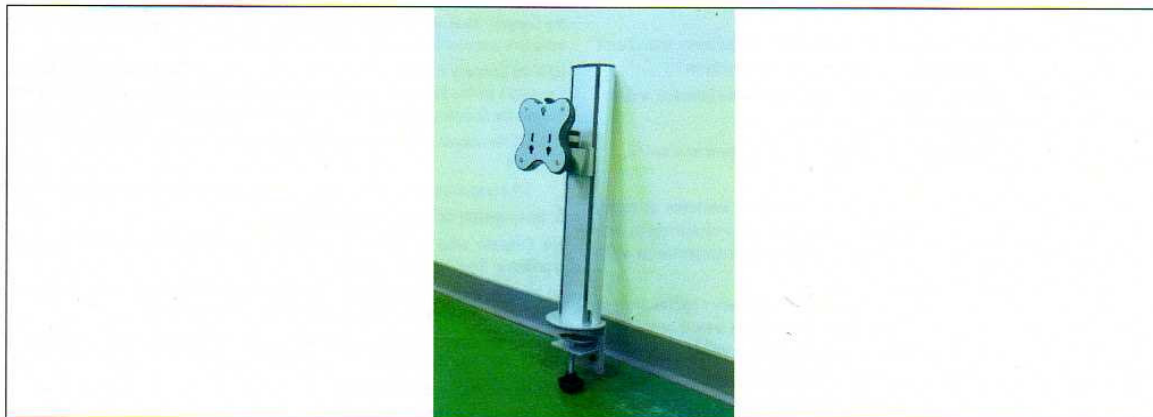
Photo "A": Appearance of Sample

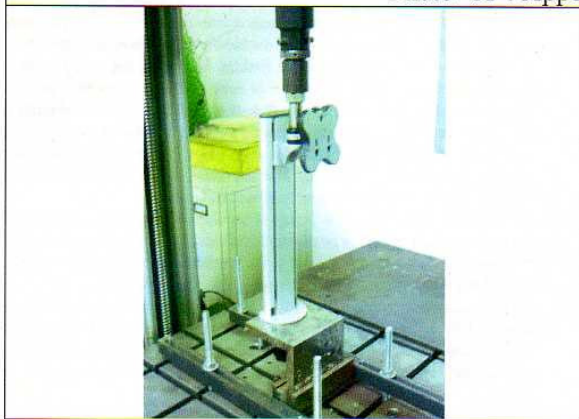
Photo "B": Test Setup

1. Place the sample (LCD Monitor Arm) on the test platform. (See "photo B")
2. Apply a downward load on the sample until it is broken.
3. Record the Max. compression load and failure mode.
4. Testing machine: INSTRON 5581, Speed: 10 mm/min.

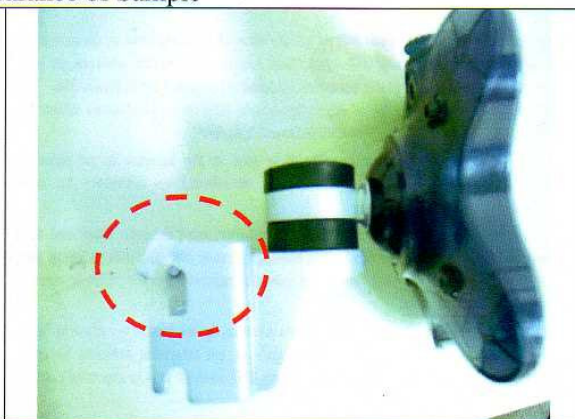
Photo "C": Failure Mode

Sample No.	Max. Compression Load	Failure Mode
#1	450.5 kgf	The sample was damaged. (See "photo C")
